HAYDEN
BUILDING

681-683 WASHINGTON ST.
BOSTON, MA 02111

ISSUED FOR CONSTRUCTION

**FOURTH FLOOR
PLAN & RCP**

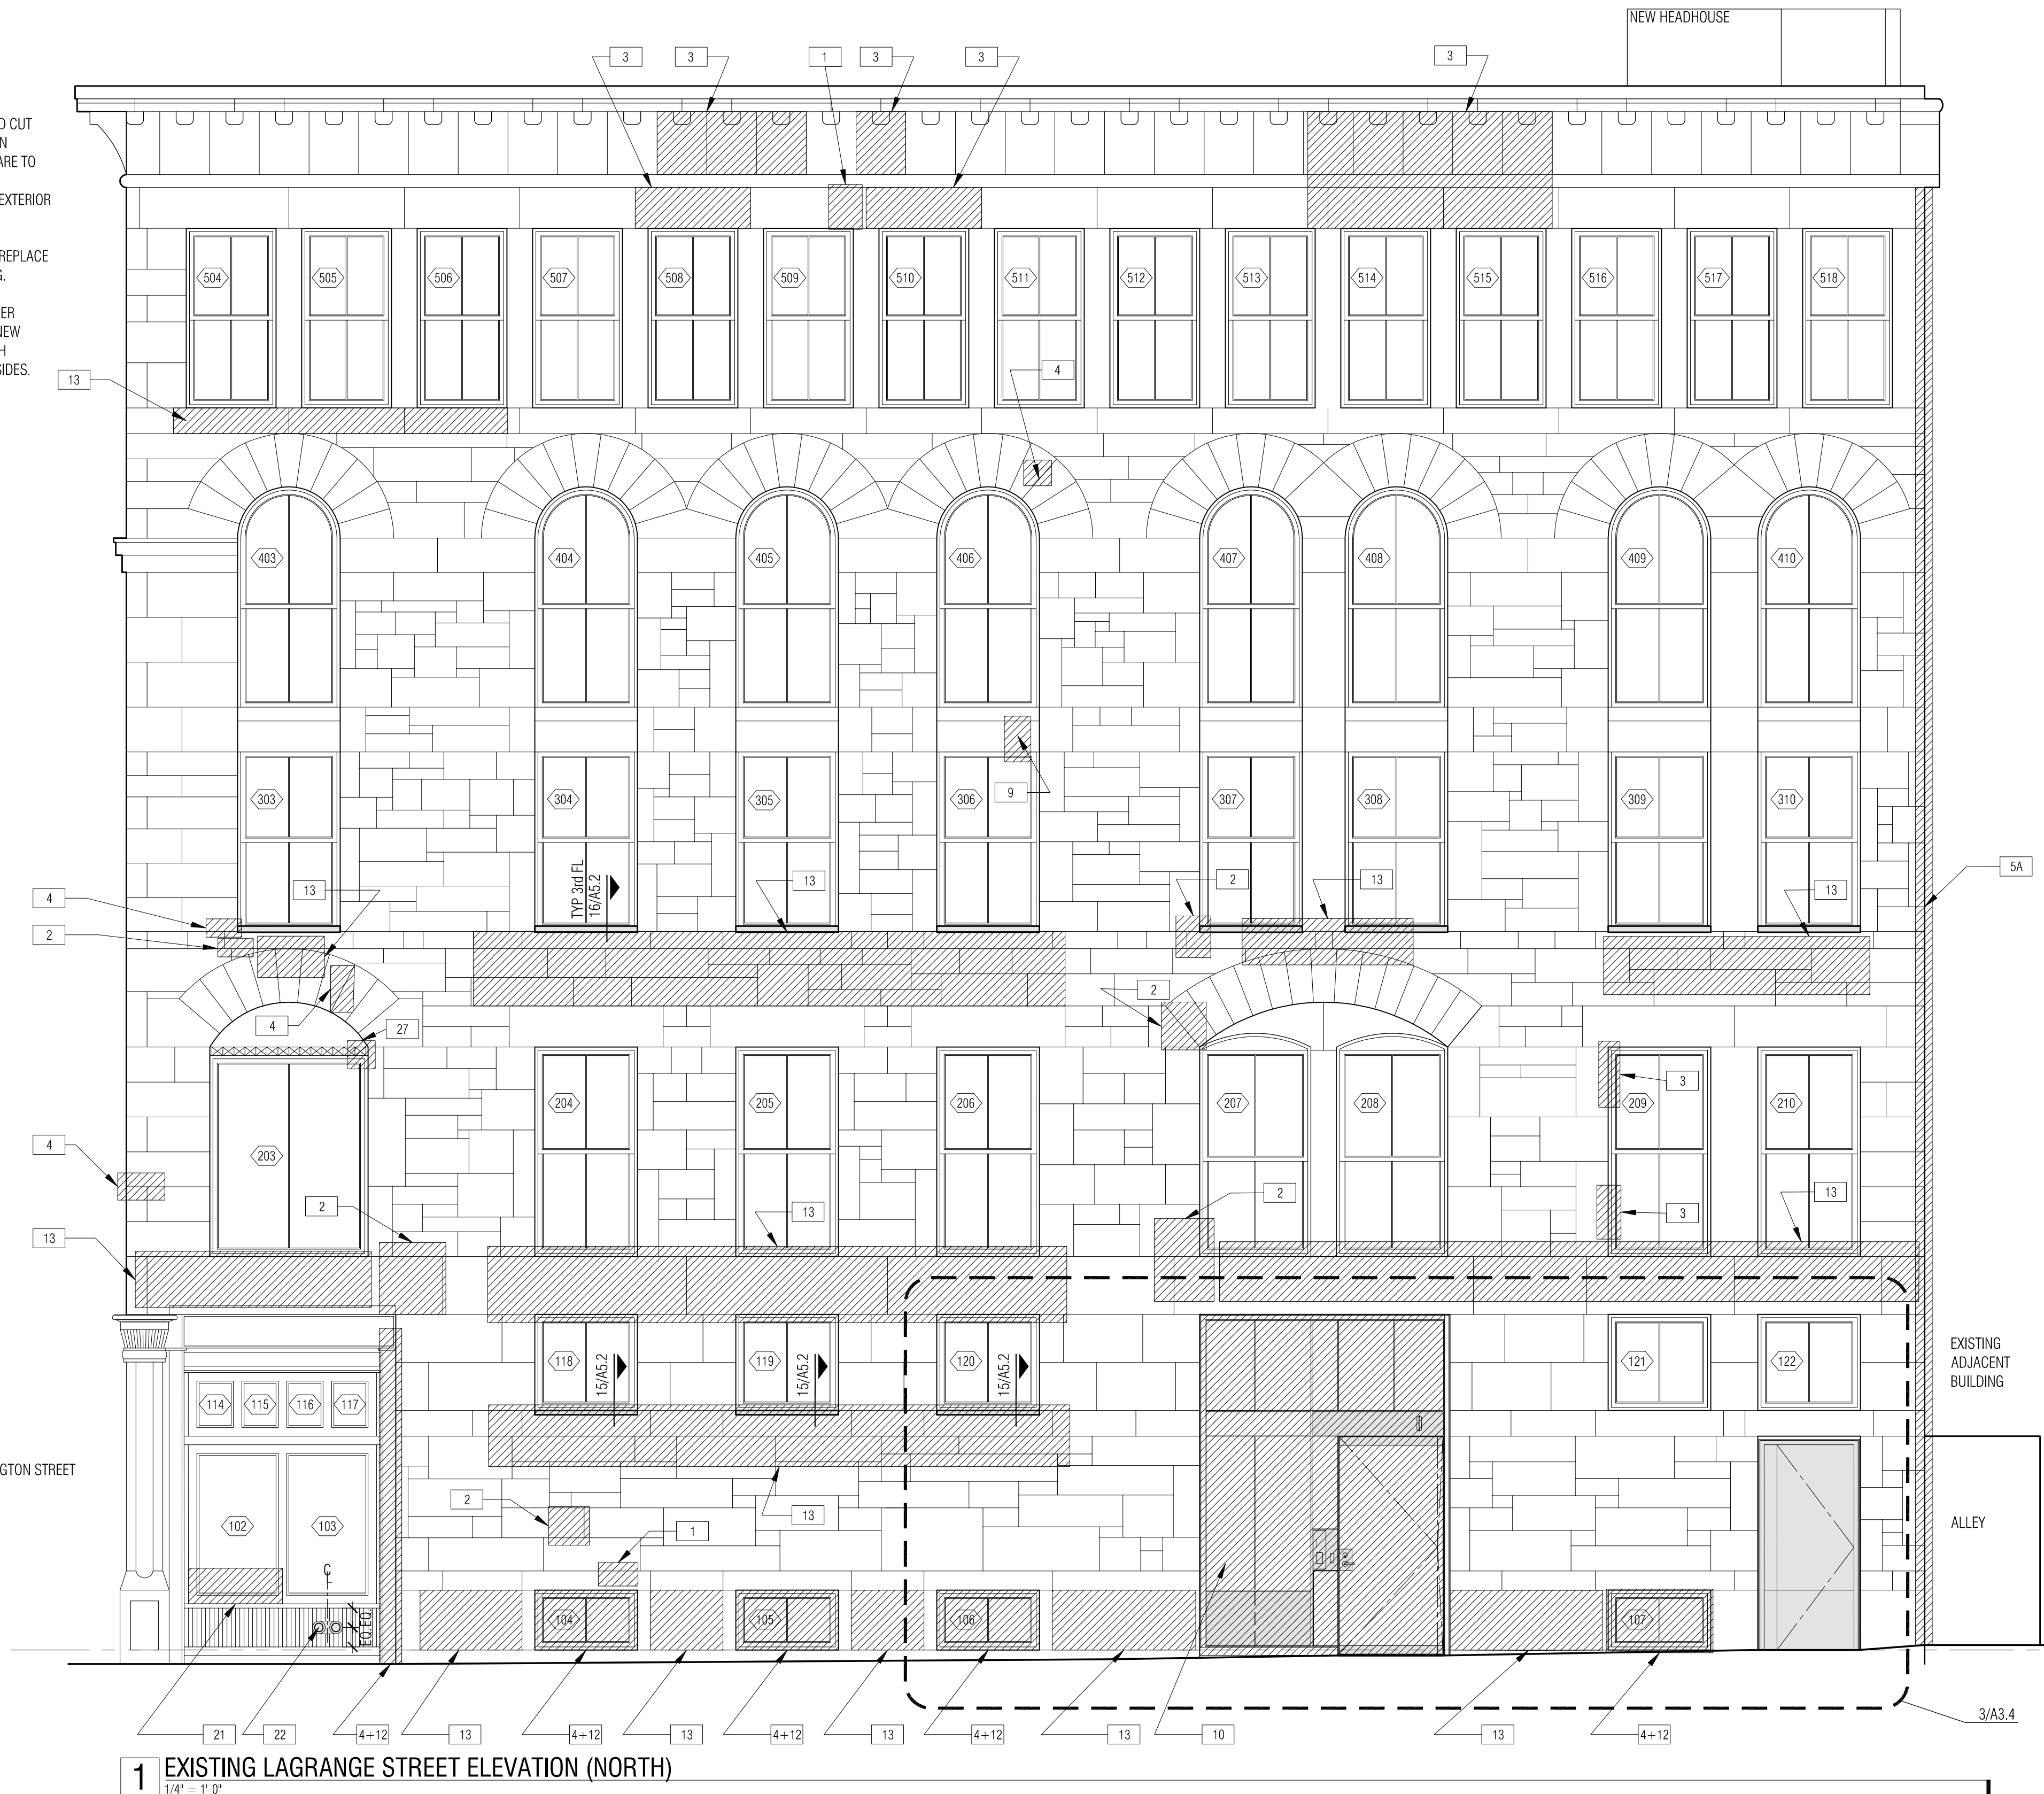
EXISTING
REPAIR

1	BROWNSTONE FACADE COMPONENT IS CRACKED AND WILL REQUIRE DOWEL REINFORCING, ROUTING OF THE CRACK, AND EPOXY INJECTION, THIS WORK CAN BE PERFORMED WITH THE MATERIAL IN PLACE.	1
2	BROWNSTONE FACADE COMPONENT IS CRACKED AND WILL REQUIRE ROUTING OF THE CRACK, AND EPOXY INJECTION, THIS WORK CAN BE PERFORMED WITH THE MATERIAL IN PLACE.	2
3	BROWNSTONE FACADE COMPONENT IS/HAS SPALLED, THE SPALLING MATERIALS SHOULD BE REMOVED, THE RESULTING EXPOSED SURFACE SHOULD BE REVIEWED FOR CRACKING AND ANY CRACKS EPOXIED TO STABILIZE AND MINIMIZE THE INTRUSION OF WATER.	3
4	SPOT POINT OPEN BROWNSTONE JOINTS. THESE ARE GENERALLY SMALL AND LOCALIZED. AS THE EXTERIOR REVIEW WAS PERFORMED FROM THE GROUND WITH BINOCULARS IT IS RECOMMENDED THAT THE FACADE BE CLOSELY EVALUATED DURING THE COURSE OF THE WORK FOR ADDITIONAL AREAS REQUIRING SPOT REPOINTING.	4
5	SPOT POINTING OF OPEN OR DETERIORATED MASONRY JOINTS. EXCAVATE MORTAR TO SOLID MATERIAL (MIN. 1" DEPTH) AND REPOINT. THIS CONDITION OCCURS ON BOTH THE INTERIOR AND THE EXTERIOR.	5

5A	REPOINTING OF AN ENTIRE AREA AS INDICATED, INCLUDING RESETTING OF LOOSE OR SHIFTED UNITS.	1

REPLACEMENT OF CRACKED, DAMAGE, OR MISSING MASONRY UNITS AND SPOT POINTING OF ANY ADJACENT CRACKED MORTAR JOINTS. THIS CONDITION OCCURS ON BOTH THE INTERIOR AND EXTERIOR.

INFILL SCUPPER WITH MASONRY TO MATCH.

REPLACE THE MORTAR WASH ON THE EXTERIOR STEPS IN THE MASONRY OF THE SOUTH ELEVATION. THE PROFILE OF A PREVIOUS ADJACENT BUILDINGS CAN BE SEEN IN THE BRICK WORK, WHICH CURRENTLY EXISTS AS STEPS IN THE FACADE. THESE STEPS HAD BEEN PROVIDED WITH A MORTAR WASH TO MINIMIZE THE INTRUSION OF WATER. THE MORTAR WASH HAS DETERIORATED AND SHOULD BE REPLACED ALONG ITS ENTIRE LENGTH ON EACH OF THE STEPS.

REMOVE UNUSED ANCHORS AND HARDWARE AND PATCH RESULTANT HOLES WITH MINERAL BASED REPAIR MORTAR SUCH AS MANUFACTURED BY JAHN. THERE ARE A NUMBER OF LOCATIONS ON THE BUILDING, PREDOMINANTLY ON THE EAST ELEVATION, WHERE OLD ANCHORS HAVE BEEN REMOVED LEAVING HOLES IN THE BROWNSTONE WHICH SHOULD BE PATCHED. THERE ARE A NUMBER OF PIECES OF UNUSED ANCHORS AND HARDWARE, MOST NOTABLY ON THE SOUTH ELEVATION, THAT SHOULD BE REMOVED AND POINTED.

STUCCO INFILL PANEL, AND CMU SUBSTRATE TO BE REMOVED FOR THE INSERTION OF A NEW ENTRY SYSTEM ON THE WEST END OF THE NORTH ELEVATION.

11	SCRAPE, SEAL, AND PAINT THE AREAS OF CRACKING AND FLAKING PAINT ON THE STOREFRONT ON THE EAST END OF THE NORTH ELEVATION AND THE EAST ELEVATION. ENSURE PAINT COLOR IS CONSISTENT WITH ENTIRE ELEMENT; SHOULD NOT APPEAR PATCHY.
12	SEAL LOCALIZED AREAS OF OPEN JOINTS BETWEEN THE WOOD TRIM AND BROWNSTONE AROUND THE STOREFRONT ON THE NORTH AND EAST ELEVATIONS, AND WOOD FRAME WINDOWS.
13	CLEAN AREAS OF ALGAE GROWTH, BOTH AT GRADE AND ON WINDOW SILLS ON THE NORTH AND EAST ELEVATIONS.
14	REMOVE EXISTING DOOR, REBUILD DETERIORATED BRICK AT HEAD AND JAMBS, INFILL PER ARCHITECTURAL PLANS.
15	EXISTING CHIMNEY OUTLET. CONTRACTOR TO VERIFY LOCATION OF CHIMNEY INLETS AND WHETHER THE CHIMNEY IS IN ACTIVE USE. IF IT IS, THEN NOTIFY OWNER OF ITS NEEDED REPAIR. IF IT IS NOT IN USE, THEN REPOINT THE WALL OF THE CHIMNEY TO STABILIZE IT AND CAP THE TOP TO PREVENT WATER INFILTRATION. REPOINT WALL PORTION ABOVE TO PARAPET

16	VOIDS IN THE MASONRY WALLS BEHIND THE STONE FACADE SHOULD BE INFILLED SOLID WITH MASONRY TO PROVIDE CONTINUITY OF THE EXTERIOR WALL.

17	SPOT POINTING ON THE INTERIOR OF THE BASEMENT STONE FOUNDATION. THOUGH THIS LIKELY WON'T RESOLVE THE WATER PENETRATION ISSUE AT THE NORTHEAST AND NORTHWEST CORNER OF THE BASEMENT, IT WILL STABILIZE AND MINIMIZE ANY SHIFTING OF THE FOUNDATION STONES. THE WATER PENETRATION IN THE BASEMENT WILL NEED TO BE RESOLVED AT THE POINT OF ORIGIN OUTSIDE OF THE BUILDING. IT IS SUSPECTED THAT THE LEAK IS WITHIN THE CITY PIPE/MANHOLE ACCESS OUTSIDE THE FOUNDATION WALL.
18	MORTAR SET EXISTING DRY STACK STONE.
19	REPLACE DETERIORATED WINDOW SILL.
20	EXISTING FIRE BEACON, MOUNT NEW KEY BOX 2" BELOW
21	REPLACE MISSING INTERIOR GLAZING STOPS ON THE WOOD STOREFRONT ON THE FIRST FLOOR OF THE NORTH AND EAST ELEVATIONS.
22	NEW FIRE DEPARTMENT CONNECTION LOCATION

23	CLEAR DEBRIS FROM THE ROLL-UP SCREEN ON THE WASHINGTON STREET ELEVATION. RECONNECT ROLL-UP SCREEN IN WORKING ORDER. ENSURE CLOSING DOES NOT TO INTERFERE WITH FIRE BEACON AND KEY BOX.
24	REMOVE BRICK WYTHES OF CHIMNEY UNTIL FLUSH W/ADJACENT WALL. AFTER REMOVING CLEAN EXPOSED BRICK TO MATCH ADJACENT.
25	NEW MASONRY OPENING
26	FLUSH STUCCO OUT W/FULL LINTEL, EDGE TO EDGE, MATCH EXISTING STONE TEXTURE, COLOR AND PROFILE.
27	DUTCH MAN REPAIR. NEW STONE TO MATCH EXISTING STONE TEXTURE, COLOR AND PROFILE. EPOXY IN PLACE WITH STAINLESS STEEL THREADED ROD.
28	NEW STEEL LINTEL, SEE STRUCTURE.
29	EXISTING BRICK POCKETS TO REMAIN. DO NOT INFILL TYP.
30	EXISTING CHIMNEY INLETS TO BE CLEANED OF DEBRIS, FILLED W/INSULATION, AND PATCHED WITH STEEL COVER PLATE, PTD. SEE ARCHITECTURAL DETAIL.
31	EXISTING STEEL LINTELS ON 2ND FLOOR INTERIOR TO BE CLEANED OF RUST AND COATED WITH COLD GALVANIZING COMPOUND

1. REMOVE ALL INTERIOR WOOD FURNISHING AND CUT NAILS FROM WALLS AND CEILINGS/JOISTS. ON WASHINGTON AND LAGRANGE SIDES TAKE CARE TO DIFFERENTIATE STEEL NAILS FROM THRU-THROUGH-WALL STEEL TIE-BACKS HOLDING EXTERIOR STONE BACK. DO NOT CUT STEEL TIE-BACKS.
2. AT ALL EXTERIOR WINDOWS REMOVE AND REPLACE SEALANT AND BACKER ROD, MATCH EXISTING.
3. REMOVE FASCIA AND REPLACE WITH COPPER FASCIA AT FULL BUILDING PERIMETER WITH NEW ROOF MEMBRANE. SEE ROOF DETAILS. MATCH LAGRANGE STREET FASCIA HEIGHT FOR ALL SIDES.

2 EXISTING WASHINGTON STREET ELEVATION (EAST)

1 EXISTING LAGRANGE STREET ELEVATION (NORTH)
